DIAMOND CHAIN LIFE

Fit the Chain to the Job

Estimated Chain Life

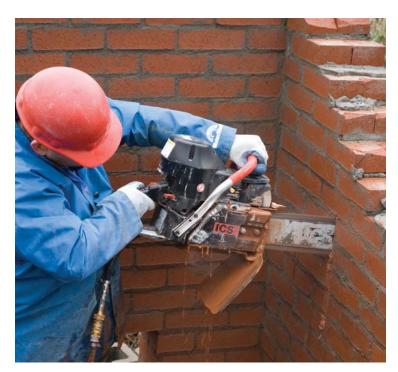
The Job, and the many variables involved, is a key determinant of chain life.

CHAIN LIFE FACTORS						
LESS LIFE		MORE LIFE				
Hard Flint	AGGREGATE HARDNESS	Soft Limestone				
Heavy	STEEL REINFORCING	Light				
Beginner	OPERATOR EXPERIENCE	Expert				
Green	CONCRETE AGE	Hardened				
Horizontal	CUTTING DIRECTION	Vertical
